US Army Corps
of Engineers®

Aliso Creek Mainstem Ecosystem Restoration Study

Without-Project Economic Analysis

Draft
October, 2009

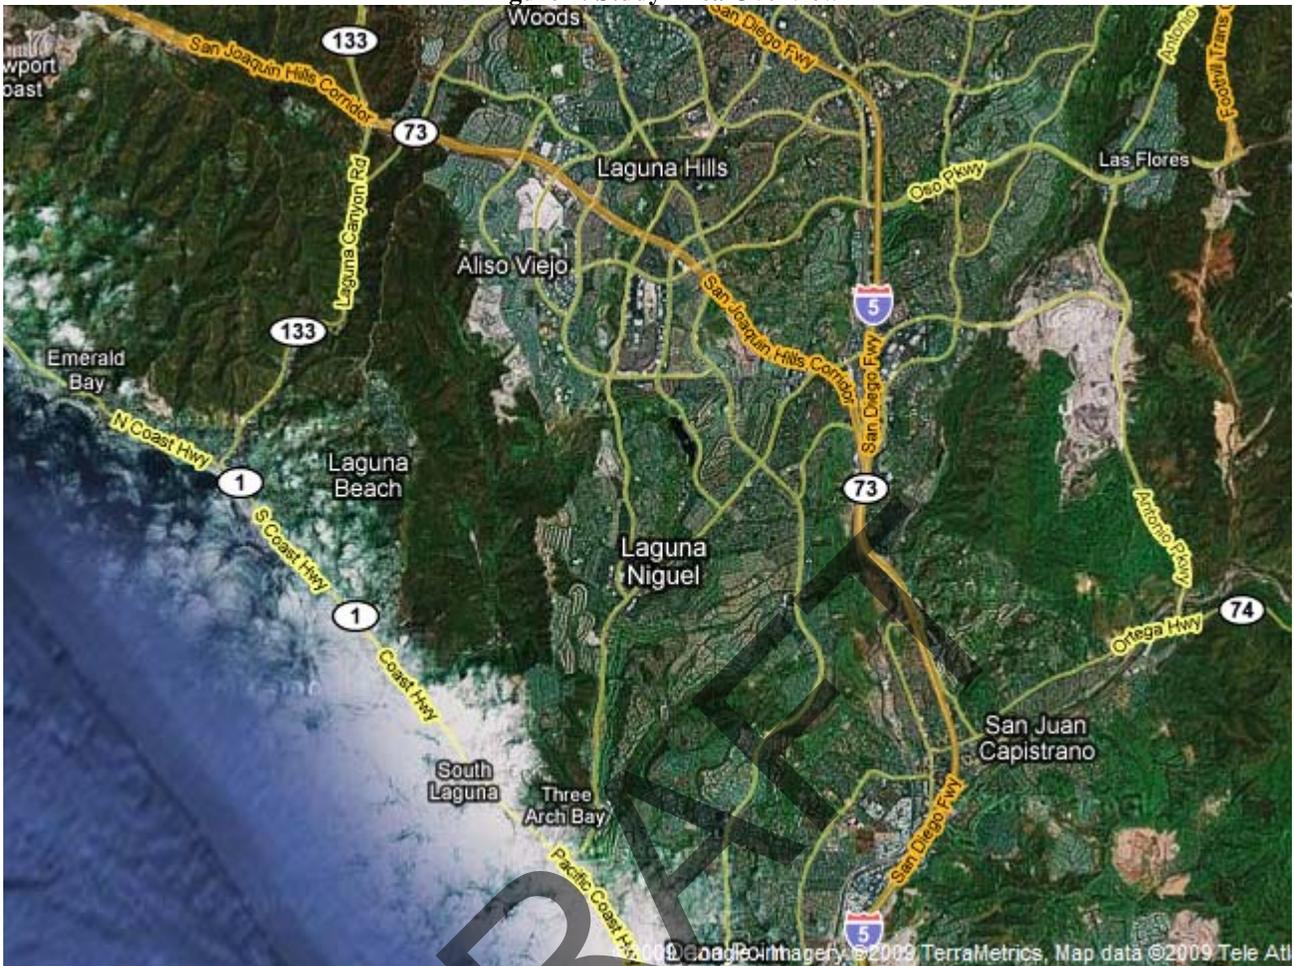
Figure 1: Study Area Overview

The study area is located within the Aliso Creek watershed which is located in southern Orange County, California. The creek flows nearly 20 miles from its headwaters at approximately 2,400 feet above sea level in Cleveland National Forest's Santiago Hills to its outlet at the Pacific Ocean near South Laguna Beach. The headwaters begins in a natural and rugged mountain environment, which transitions to more level floodplain in the middle reaches, and on through a narrow coastal canyon on the way to its ocean inlet. In particular, the study area only focuses on the downstream segment of the watershed, beginning at Aliso Viejo Parkway and extending to the Pacific Ocean, a distance of about 8.2 miles.

Communities within the watershed area include Portola Hills, Mission Viejo, Lake Forest, El Toro, Laguna Hills, Laguna Woods (Leisure World), Aliso Viejo, Laguna Niguel, and Laguna Beach. Major tributaries to Aliso Creek include English Canyon, Sulphur Creek, and Wood Canyon.

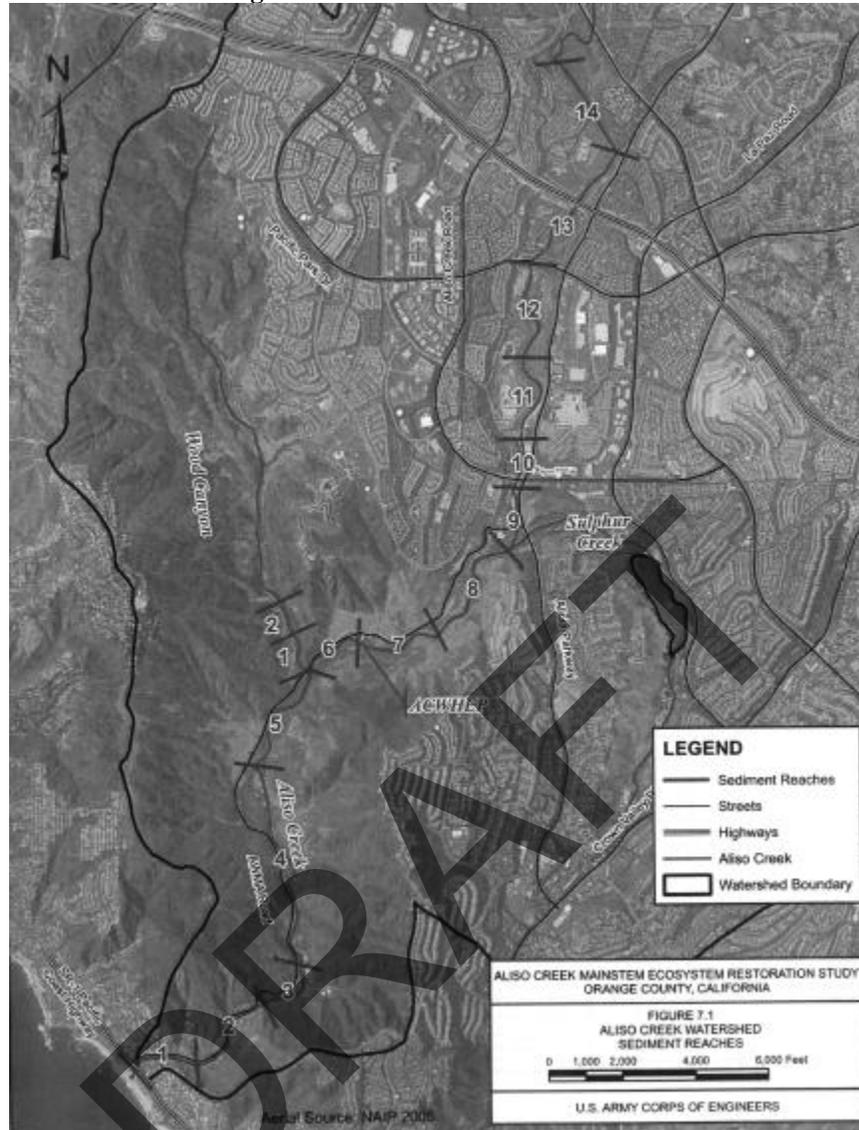
Figure 2: Aerial View of The Reaches

The study area is divided into 14 reaches to facilitate the economic assessment and the geographic description of without project conditions. The 14 reaches are identified in the table below were identified in the Hydraulic and Hydrologic (H&H) Appendix. Also, the H&H Appendix provides figures that show geographical location of the station numbers that were incorporated into this study.

According to the information presented in the H&H Appendix, the 14 reaches were delineated according to the hydraulic conditions along the creek. With this in mind, reaches were delineated based on slope, existing hydraulic and bed controls (e.g., bridges, drop structures, etc.), and on a comparison of hydraulic parameters, primarily top width and velocity. The following figure provides an aerial view of the location of the 14 reaches. The description of the reaches presented in this report matches those included in the H&H Appendix.
